## DOUBLE-ACTING HYDRAULIC CYLINDER

Max. Capacity: 65.7 Tons At 10,000 PSI

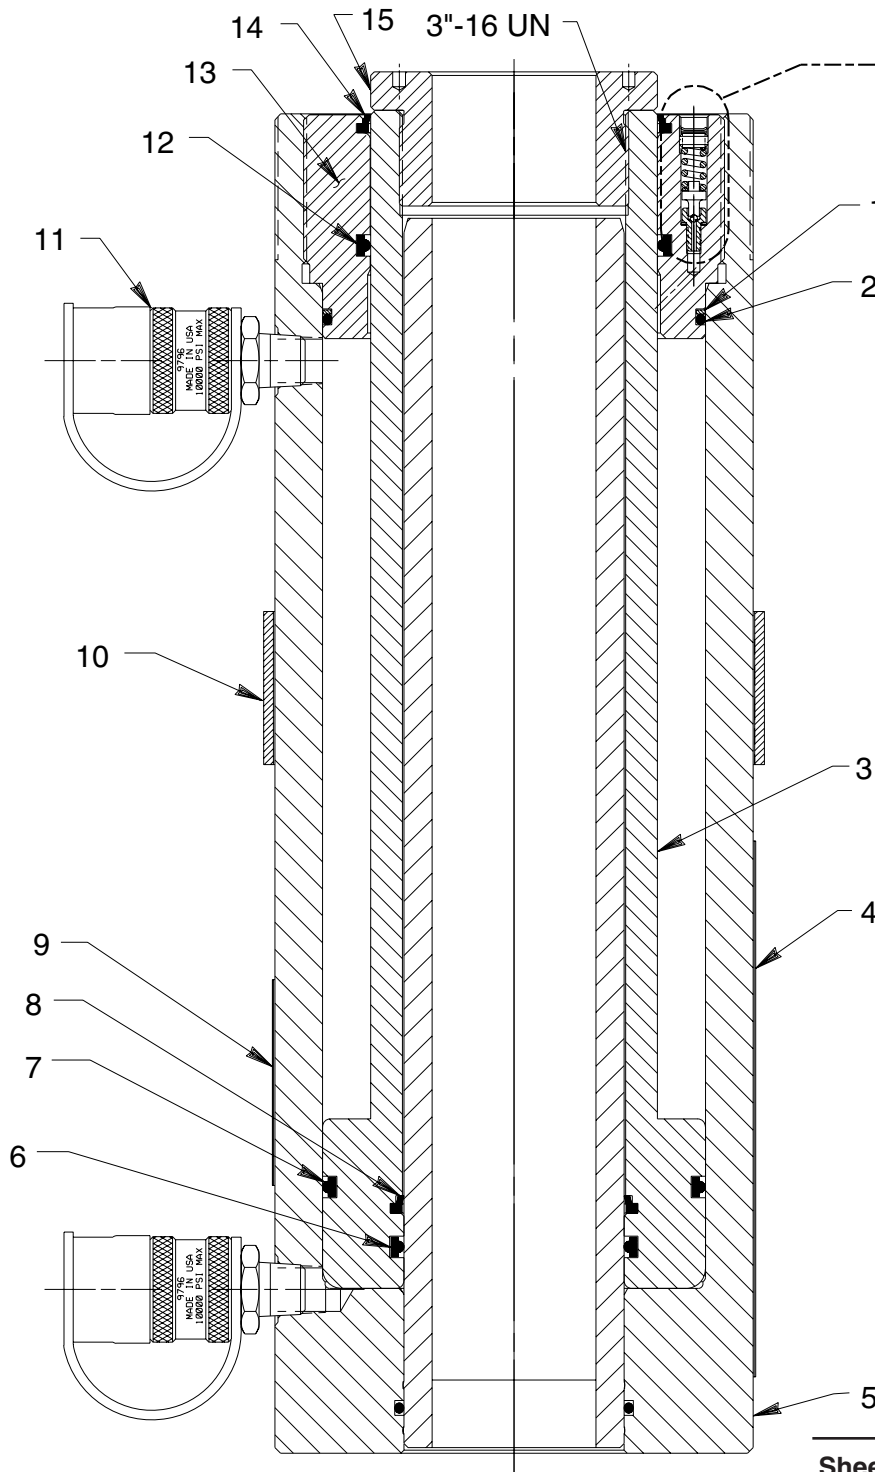
Double-acting  
Cylinder  
Relief Valve

- In the event that the cylinder retract port is ever restricted or plugged, a double-acting cylinder relief valve will help prevent excessive pressure from building in the cylinder. **DO NOT** attempt to adjust or service this relief valve! If oil leakage is detected from this relief valve, discontinue use of the cylinder immediately and contact Power Team Technical Services. Only Power Team Authorized Hydraulic Service Centers should service this relief valve.
