**SINGLE-ACTING, SPRING RETURN, PULL - 2 TON  
HYDRAULIC CYLINDER**

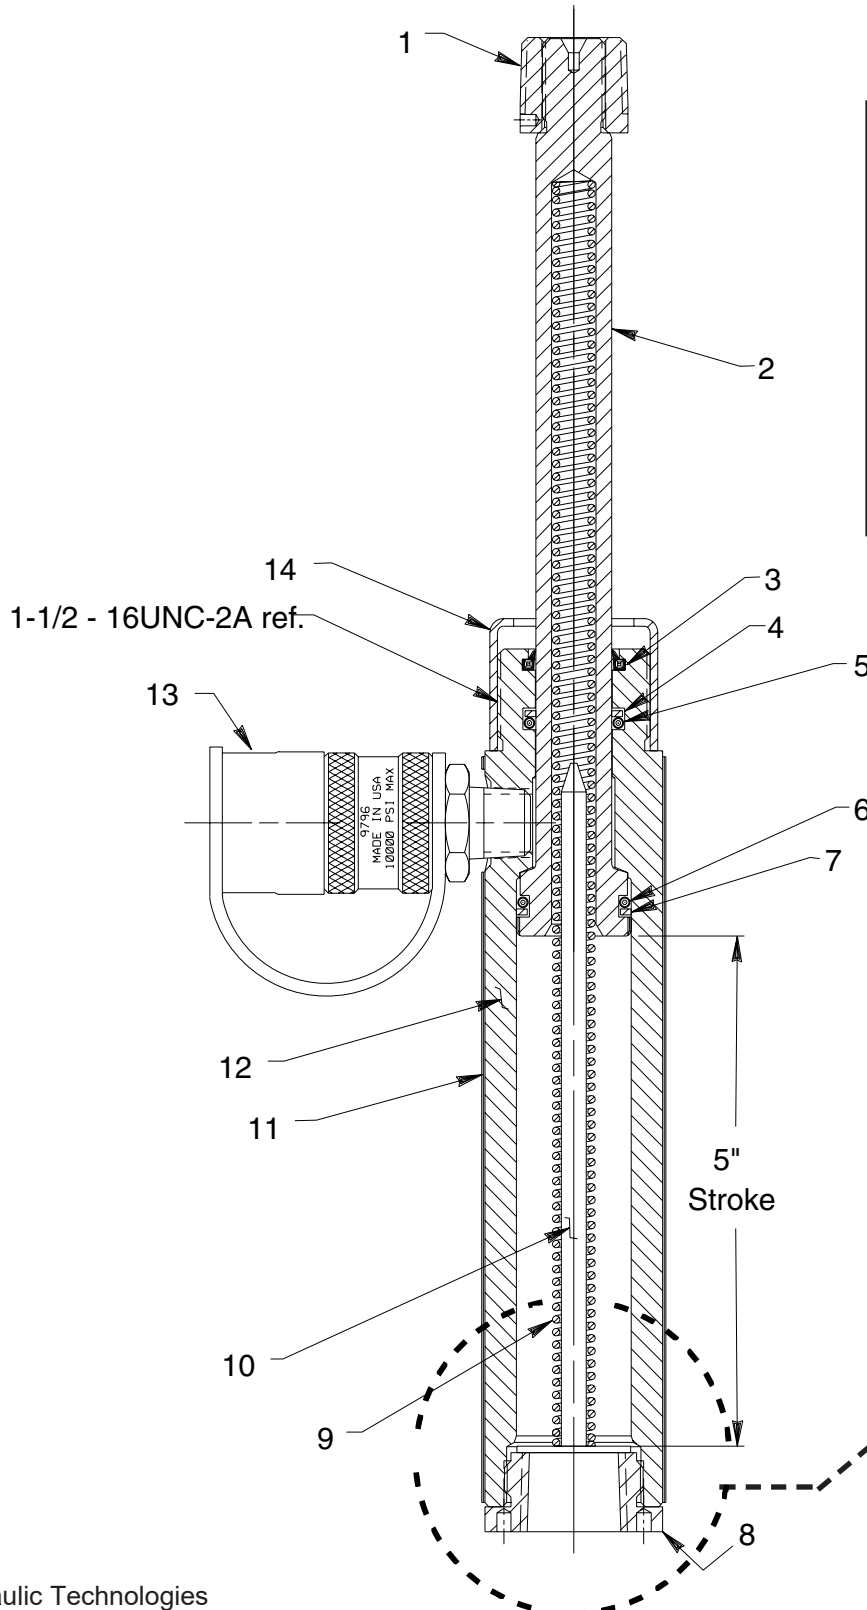
**WARNING:**  
To help avoid personal injury, use extreme care when disassembling this cylinder. The threaded end cap (Item #8) is loaded with 40 lbs. of spring force and releasing this spring force improperly could result in bodily harm.

| Item No. | Part No. | No. Req'd | Description |
|---|---|---|---|
| 1 | 250820 | 1 | Threaded Piston Adapter (For RP25;<br>NOTE: Apply Loctite 242 or equivalent<br>to last two threads and torque to 30/35 ft. lbs.) |
| 2 | 420483 | 1 | Piston Rod |
| 3 | *250822 | 1 | Rod Wiper |
| 4 | *19138 | 1 | Backup Washer (1" x 3/4 x .048) |
| 5 | *10276 | 1 | O-ring (1" X 3/4 X 1/8) |
| 6 | *10278 | 1 | O-ring (1-1/8 X 7/8 X 1/8) |
| 7 | *19139 | 1 | Backup Washer (1-1/8 x 7/8 x .048) |
| 8 | 250816 | 1 | Threaded End Cap (NOTE: Apply Loctite 242<br>or equivalent to last two threads and torque to 30/35 ft. lbs.) |
| 9 | 250821 | 1 | Compression Spring |
| 10 | 250817 | 1 | Spring Guide Weldment |
| 11 | 350441 | 1 | Trade Name Decal |
| 12 | 420482 | 1 | Cylinder Body |
| 13 | 9796 | 1 | Ram Half Coupler w/ Plastic Dust Cap (For RP25) |
| | 11127 | 1 | Drive Plug (For RP25-CREN & RP25-PAC) |
| 14 | 36141 | 1 | Plastic Thread Protector (For RP25 & RP25-CREN) |

Part numbers marked with an asterisk (\*) are contained in Standard Repair Kit No. 300628.
